STATE OF CALIFORNIA
DEPARTMENT OF TRANSPORTATION
DIVISION OF CONSTRUCTION
OFFICE OF TRANSPORTATION LABORATORY

EVALUATION OF WEATHERING
EFFECTS ON STRUCTURAL STEEL

1. REPORT NO. FHWA/CA/TL-82/04		2. GOVERNMENT ACCESSION NO.		3. RECIPIENT'S CATALOG NO.	
4. TITLE AND SUBTITLE EVALUATION OF WEATHERING EFFECTS ON STRUCTURAL STEEL				5. REPORT DATE March 1982

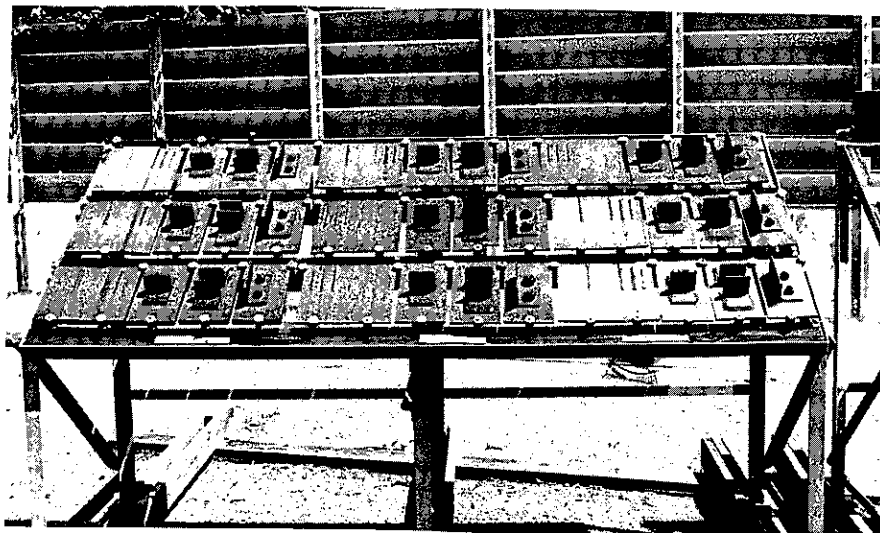
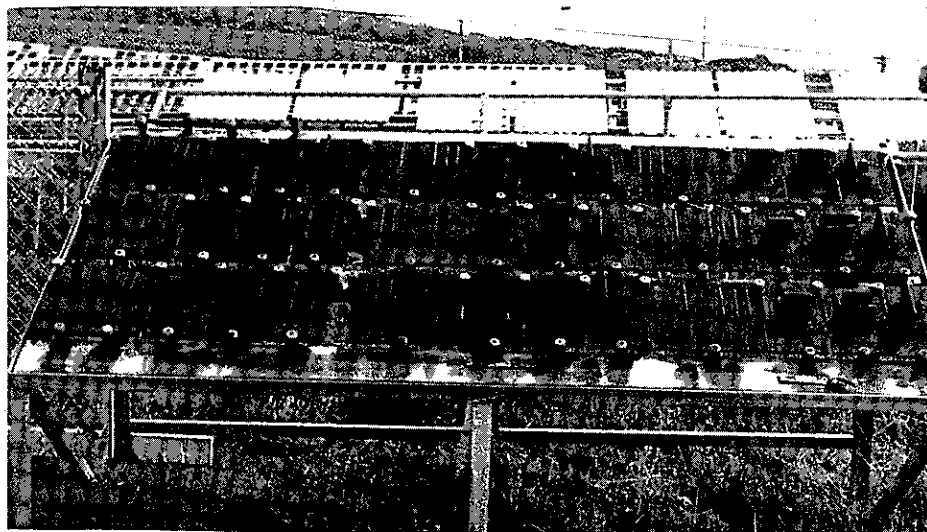
The specimens were held in place with ceramic insulators and spaced so that material washed from one would not contaminate another as can be viewed in Figure 11 which shows the specimens in place on the weathering racks at approximately 13 years.

SACRAMENTO

POINT REYES

LOS ANGELES

The Point Reyes site is located on the ASTM corrosion test site on the Point Reyes peninsula 1/4 mile from the ocean. The rack was inclined 30° from the horizontal and faced west.

In Los Angeles, the weathering rack was placed at ground level at a California Department of Transportation Maintenance Station close to the Santa Ana Freeway (Interstate 5) in the City of Commerce which is a few miles southeast of the center of Los Angeles. This rack was inclined at 30° to the horizontal and faced east.
